Manhole Inspection Summary

Manhole # S17GG2016MH

Insp Date: **10/4/06 1:17 PM**

Location Address: **5921 SMITH AVE**

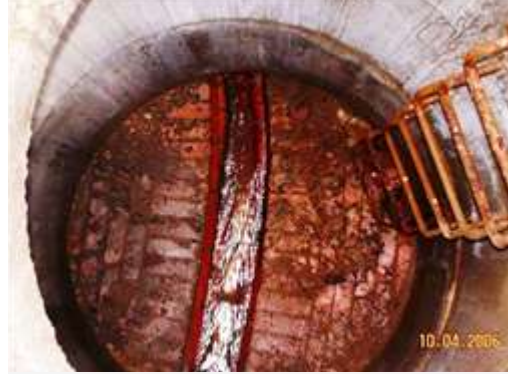
Top View

Corroded steps. Barrel infiltration.
Evidence of surcharge - Bench debris.

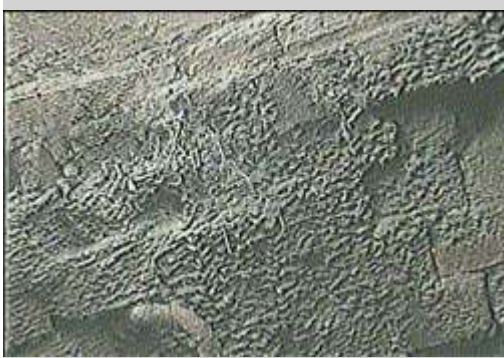
Defect

Frame leaks. Adjustment root intrusion
and infiltration.

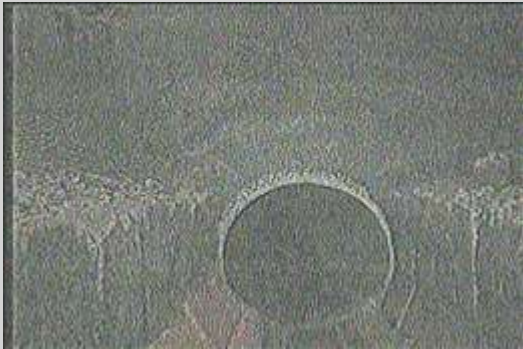
8 in. Circular Gravity Sewer Pipe Out @ 12 O'Clock

Rod and Bar (Angled)

Infiltration: **None** Pipe Seal Cond: **Unknown**

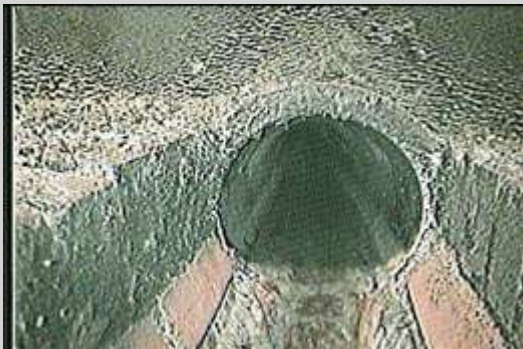
8 in. Circular Gravity Sewer Pipe In @ 6 O'Clock

Rod and Bar (Angled)

Deposits: ☐ None ☐ Mud ☐ Sludge ☐ Debris ☒ Grease

Silt Depth: **0** (in.) Deposits Extent: **Light**
